# Karaka Wetland Project

## Enhancement Plan

Department of Conservation

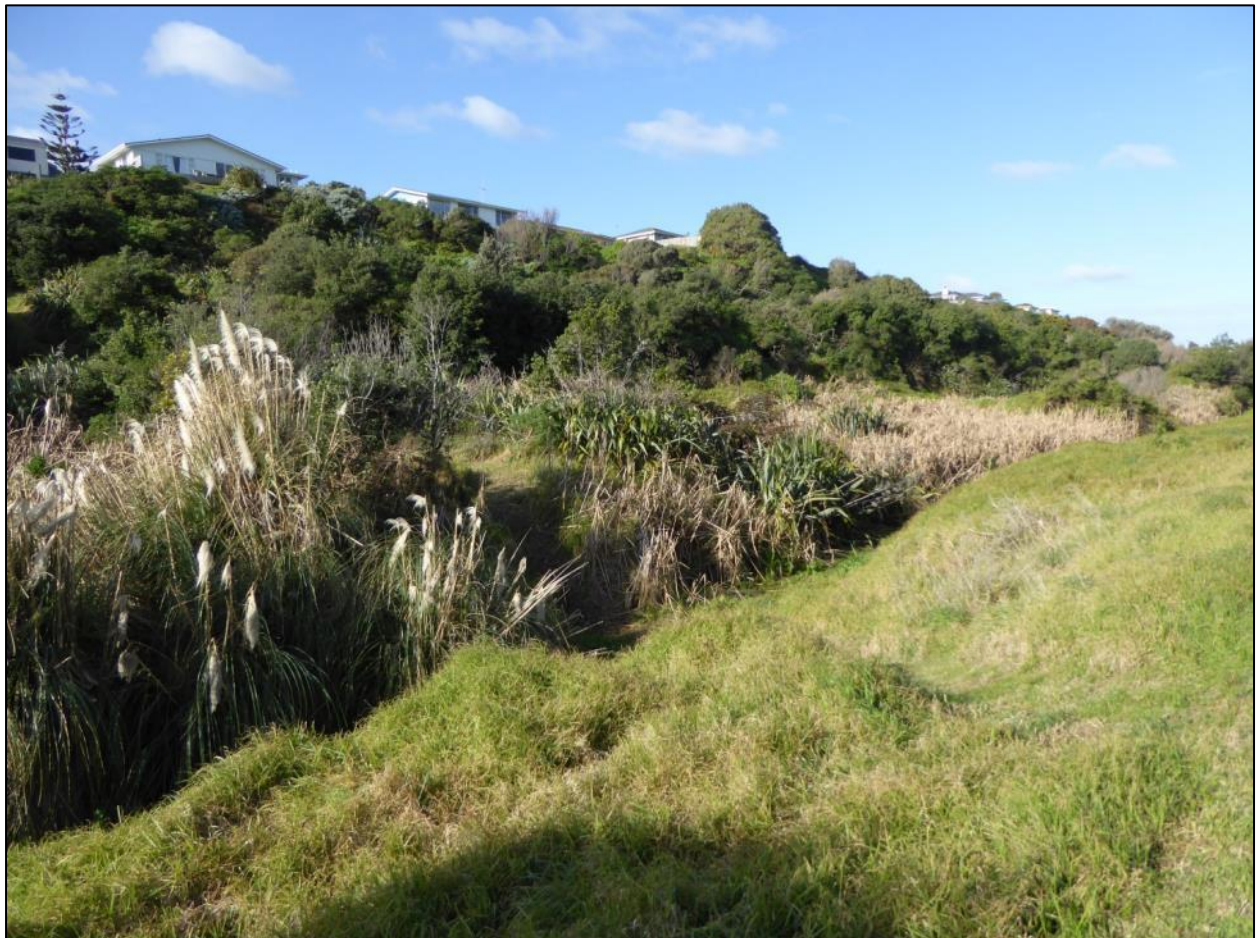
**Figure 1** View of part of the wetland showing the grassy banks of the channel, the wetland proper and the clifftop Karaka St houses.

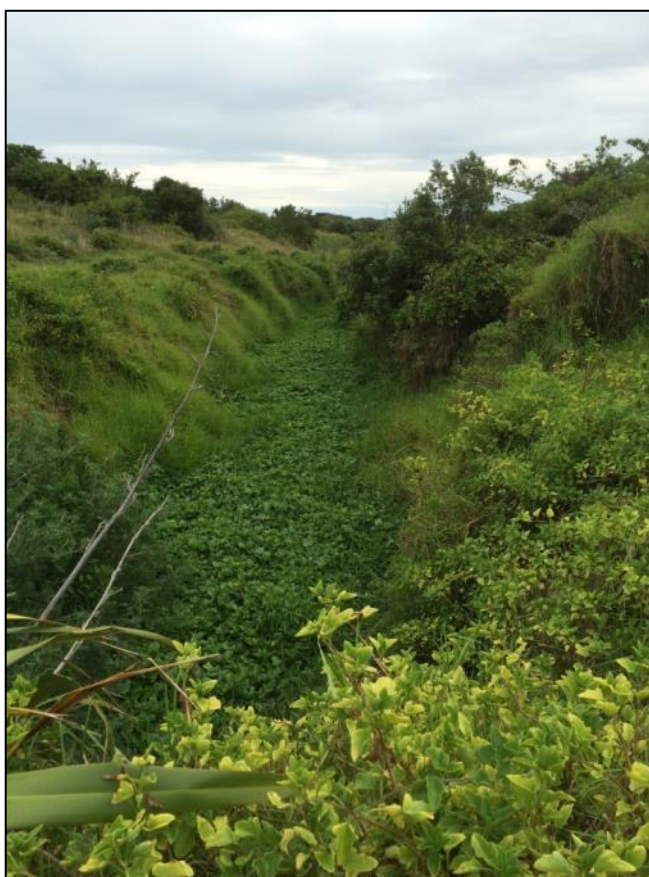
**Figure 7:** Section of channel filled with emergent Mimulus.

The channel is partly filled with raupō, monkey musk (*Mimulus guttatus*, Figure 7) and fool's watercress (*Helosciadium nodiflorum*); submerged aquatic plants *Elodea canadensis*, *Myriophyllum* spp. and starwort (*Callitriche* sp.); and floating plants *Lemna* sp. and *Azolla filiculoides*.

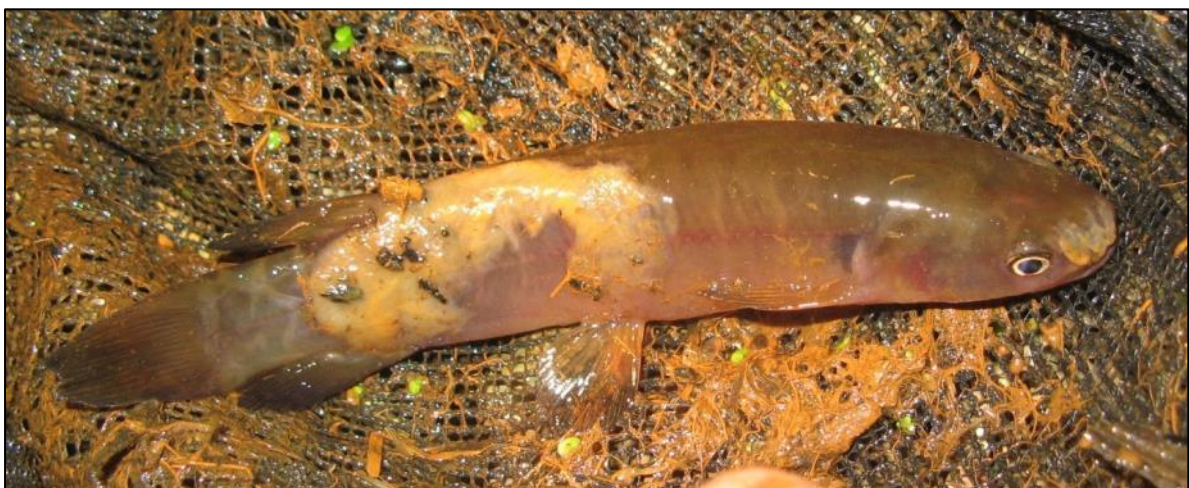
**Figure 8:** Banded kōkopu found shortly after the 2014 clearance. The creamy patch is an external infection and the reddened lateral line suggests septicaemia. It is likely that this infection was eventually fatal.

The use of a digger to remove vegetation from the channel has negative impacts on fish. The stream was visited by Stella McQueen before and after the digger was used in 2012 and 2014. After the clearance fish with injuries and infections were seen within the cleared sections, but none were seen before the clearance. Additionally, fewer fish were seen in the cleared reaches.

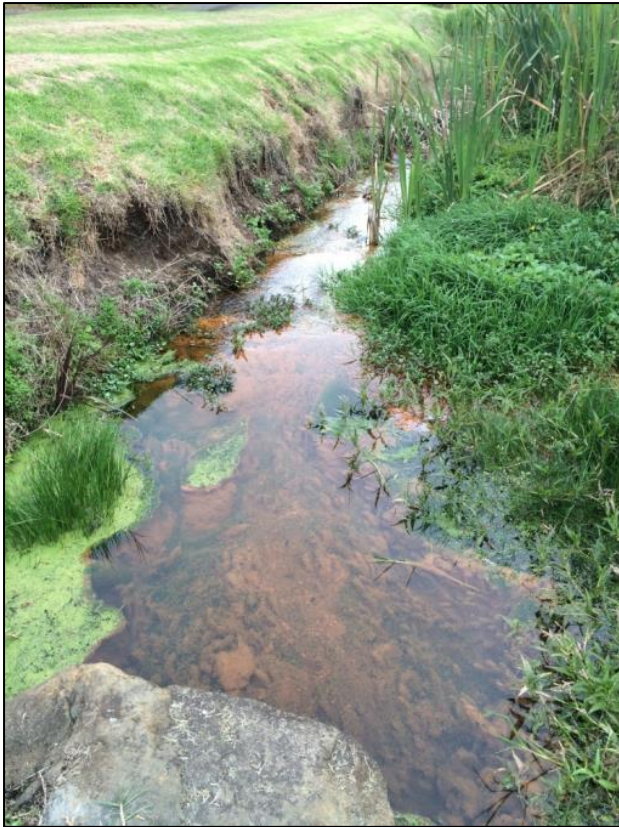
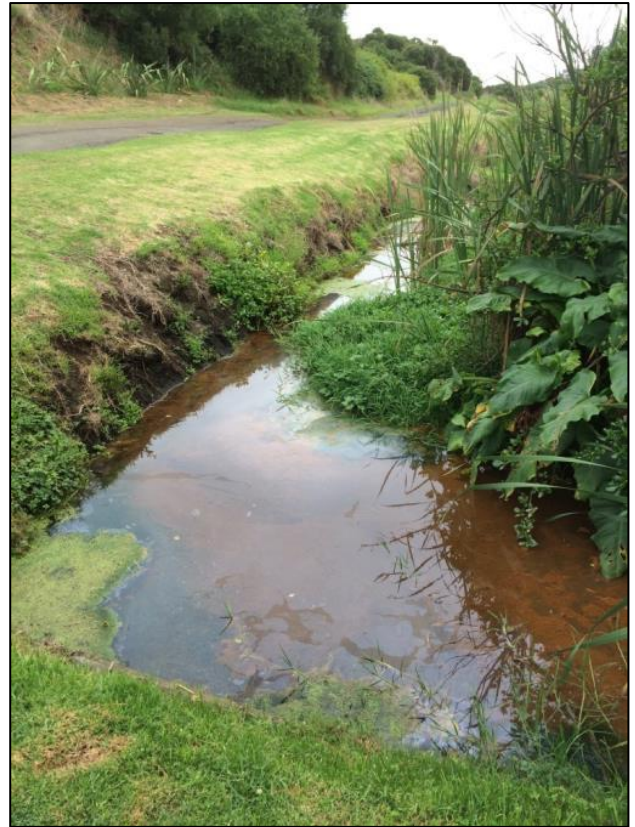
**Figure 10:** Ideal kokopu habitat, incidentally created by Karaka St residents, with slow-flowing open water and plenty of adjacent cover. Natural iron bacteria are responsible for the orange iron oxide sediment and the oil-like film.

On the Karaka Street properties, most of the area below the clifftop has been left in a natural state by the landowners, except for maintaining private paths to the culverts. Several of the residents have developed gardens on their properties extending down towards the wetland, and in some cases they have been taking care of the DOC strip adjacent to their properties. Some of these landowners have maintained open water around the culverts by manually removing raupō and other aquatic plants, incidentally creating ideal habitat for the banded kōkopu (Figure 10).

Several Karaka Street residents, in seeking to develop the channel as an attractive stream feature at the bottom of their gardens, have incidentally created good in-stream habitat for the fish. Extending what they have done along the rest of the channel would greatly expand the amount of good kōkopu habitat available in the channel (Figure 10).

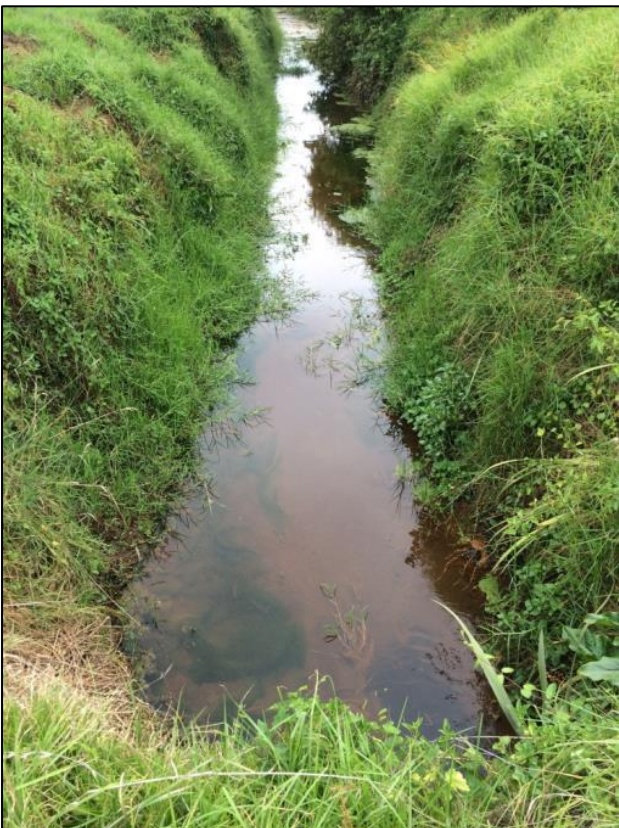
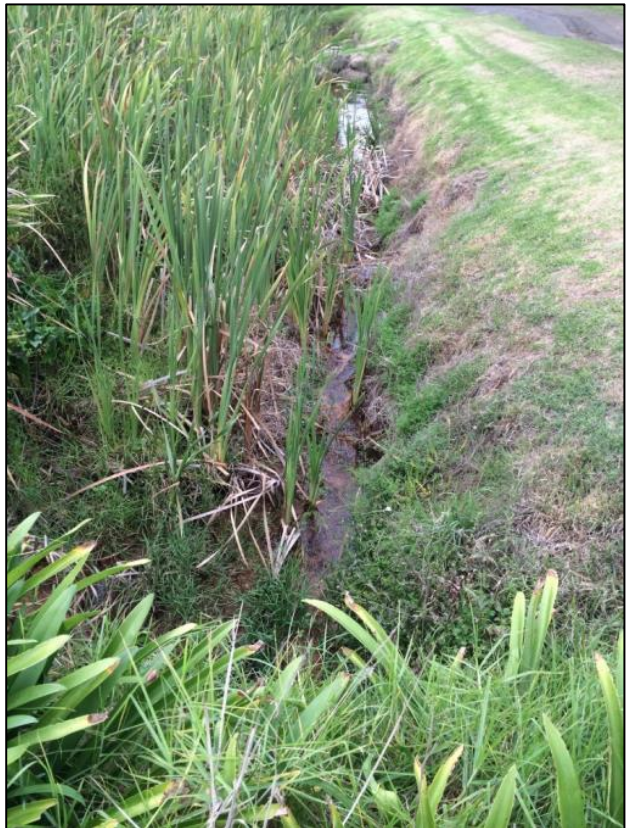
**Figure 9:** Unsuitable banded kokopu habitat. Left: The channel is too deep and slow with little cover. Right: The channel filled with raupō pushing water into a narrow, fast-flowing ribbon.

The lower half of the channel appears to have been subject to more work from the digger than the upper half. This has resulted in a very deep, steep-sided ditch with a wide, deep and extremely slow-flowing stream (Figure 9). The upstream section has had little vegetation removal and in places the raupō has grown across the channel from the wetland towards the track (Figure 9). In these areas the water is now flowing quickly in a narrow ribbon along the seaward bank. In the middle section (where Karaka Street residents have been tending the vegetation) there is a variety of medium and slow flow areas, and areas of open water are interspersed with raupō and other aquatic vegetation.
